Cost-effective approach to reducing collisions with elk by fencing between existing highway structures

Abstract: Collisions with large ungulates cause serious human and animal injuries and significant property damage. Therefore, wildlife crossing structures are increasingly included in new road construction to reduce wildlife–vehicle collisions, while still allowing wildlife to safely cross roads. Recently, state and federal transportation budgets have declined, concomitantly reducing the construction of wildlife crossing structures, which are generally tied to large-scale reconstruction projects that are delayed for decades into the future. Nevertheless, even during times of fiscal constraint or temporal delay, it is still necessary to reduce collisions with wildlife and maintain habitat connectivity. Therefore, it is important to find cost-effective and functional alternatives. Retrofitting roadways with wildlife exclusion fencing that directs animals to existing highway structures (e.g., sufficiently sized bridges and culverts) is a possible cost-effective, interim solution that needs further testing. Along Interstate-17 in northern Arizona, we heightened 9.17 km of right-of-wa

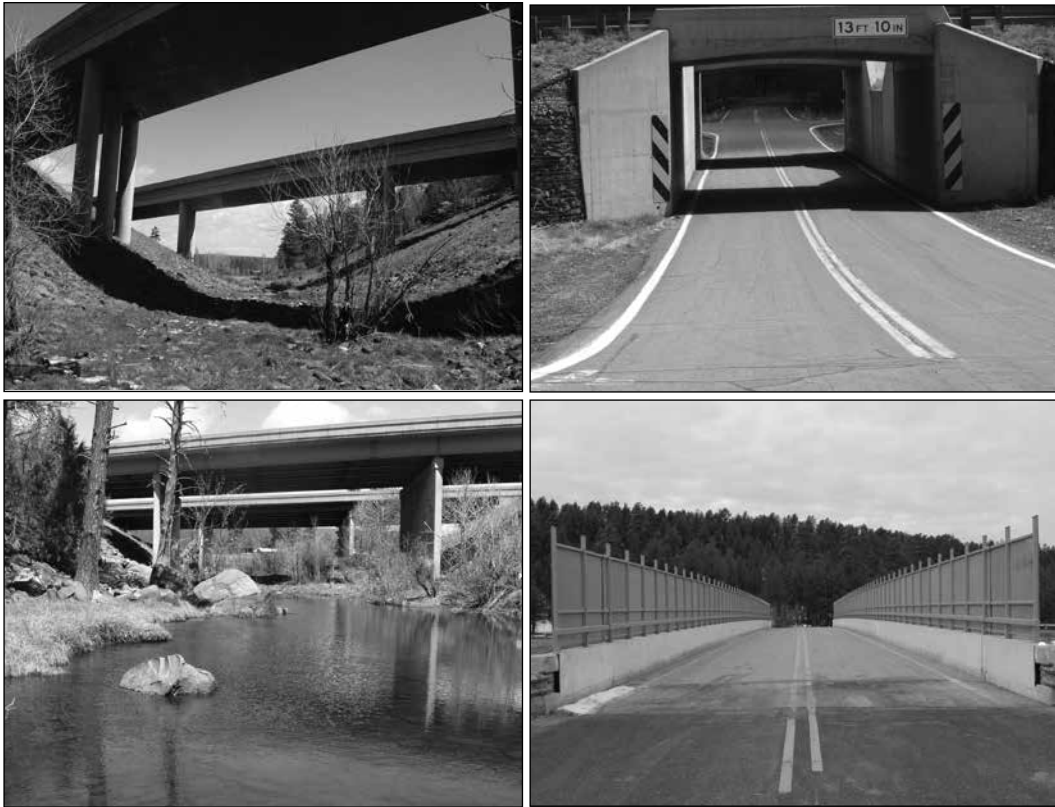
Figure 2. Four existing structures that were connected by 9.17 km of 2.4-m-high elk retrofit exclusion fencing along Interstate-17 in northern Arizona, USA (completed in February 2012). Clockwise from top left: Munds Canyon Bridge, Schnebly Hill Traffic Interchange, Fox Ranch Traffic Interchange, and Woods Canyon Bridge.

Arizona Department of Transportation worked with Arizona Game and Fish Department to gather elk movement and wildlife–vehicle collision data to incorporate wildlife crossing structures into the reconstruction plans for a 77-km stretch of I-17 (Gagnon et al. 2013). They identified 19 potential wildlife crossing structure locations for inclusion in highway reconstruction plans. Proposed wildlife crossing structures would be connected with 2.4-m-high, woven-wire fence to funnel animals to the wildlife crossing structures. However, the reconstruction was delayed, hence the need to find alternatives. Therefore, the 2 agencies focused on a 9.17-km segment that had a high incidence of elk–vehicle collision (20.3 per year, 2007 to 2010) and 4 structures with the potential to function as wildlife crossing structures (Figure 2; Table 1).

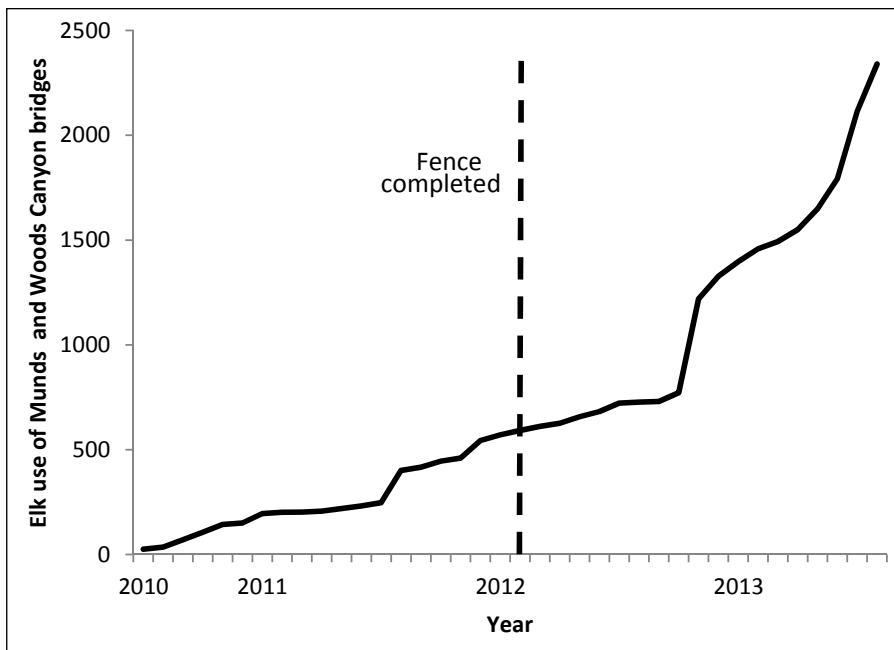
Figure 6. Cumulative number of elk crossing under Munds and Woods Canyon Bridges before (19 months) and after (19 months) a fencing retrofit to exclude elk from a 9.17 km section of Interstate-17 and connect existing structures from July 2010- August 2013, Arizona, USA.

At Munds Canyon and Woods Canyon bridges, we documented an increase in elk

crossings following installation of the retrofit fencing (Figure 6). At Munds Canyon Bridge, the larger of the bridges, we documented 545 elk crossings pre-fencing and 1,725 elk crossings post-fencing, a 217% increase. At Woods Canyon Bridge, we documented 26 elk crossings pre- and 44 crossings post-retrofit or a 54% increase.
