# Improved methods for deterring cliff swallow nesting on highway structures

**Abstract:** Cliff swallows (*Petrochelidon pyrrhonota*) are migratory birds that frequently nest on highway structures, such as bridges. Because cliff swallows are protected by the Migratory Bird Treaty Act of 1918, nesting control methods must not harm cliff swallows or disturb active nests. This can cause delays for maintenance divisions of state departments of transportation, resulting in additional cost. In a multiyear project, we evaluated the effects of bioacoustic deterrents and bridge surface modifications on nesting behavior of cliff swallows. We used cliff swallow alarm and distress calls as bioacoustic deterrents (hereafter, broadcast calls [BC]) because they previously had been shown to delay the onset of nesting. We used low-friction plastic sheeting (PTFE, commonly called by its trade name, Teflon®) and silicone-based paint for bridge surface modification. In 2007, swallows were able to complete nests on silicone paint, but did not successfully complete any nests on PTFE. In 2008, PTFE+BC treatment significantly reduced nesting compared with no treatment, although some nests were completed

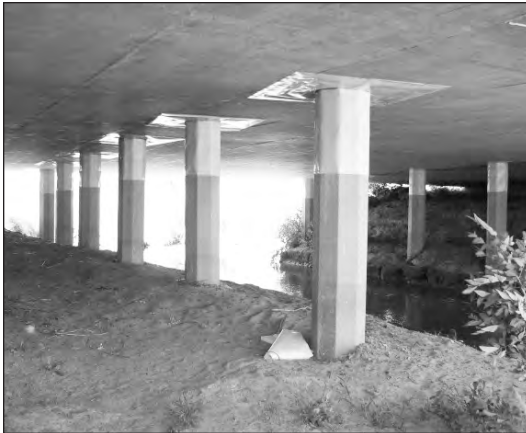
**Figure 3.** Highway structure with PTFE surface modification.

PTFE sheets used for surfaces above pier walls and drop caps were 61-cm wide for sites in 2007 and the first few bridges in 2008, after which we reduced the sheet width to 30 cm for the remaining bridges. PTFE extended 61 cm down each pile and at least 18 cm from the overhead juncture above the pile. We limited the length of sheets to 1.83 m for ease of handling. We applied the butyl adhesive strips along the edges and interior of each sheet so that any point on the sheet was no farther than 15 cm from an adhesive strip. We removed the paper backing of the butyl strips and pressed the sheets against the bridges' surfaces (Figure

3). We overlapped sheets 3 to 6 mm to provide continuous coverage of each surface with PTFE.

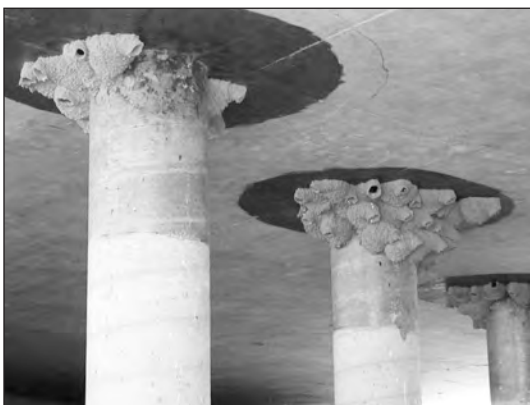
**Figure 7.** Completed nests on piles and overhead surfaces treated with silicone paint.

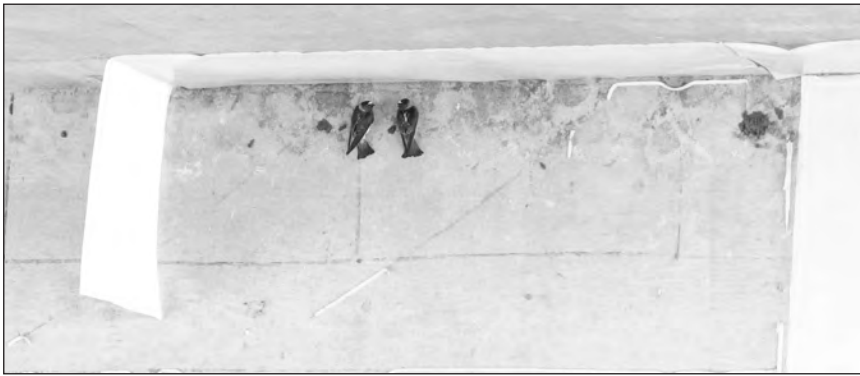
**Figure 10.** PTFE sheets detaching from the concrete bridge surface and cliff swallows building nests.

that both the PTFE and PTFE+BC treatments would have been more effective if it were not for problems with PTFE sheet adhesion to the bridge surface (Figure 10). Many of the detached sheets were installed overhead, such that the weight of the sheet pulled directly away from the bridge surface. We replaced missing PTFE sheets as quickly as possible during the first 7 weeks of the study, but at some sites we were unable to replace the sheets before the birds had built nests at that location. We included these nests in our counts, but they do not reflect the intrinsic ability of PTFE to deter nesting, assuming it is securely attached to the surface. Butyl adhesion failed at the concrete surface and at the PTFE surface in about equal proportions. This suggests that butyl sealant is not adequate for reliable surface modification treatments as conducted in this study. Thinner or smaller sheets of PTFE, or additional strips of butyl adhesive might prevent detachment from the bridge surface, but we feel that a better attachment method is needed, such as mechanical fasteners or semi-permanent epoxy adhesive.
