## Grazing on the Arizona Strip: Catchment History and Repair

Utah State University Extension

Peer-Reviewed Fact Sheet

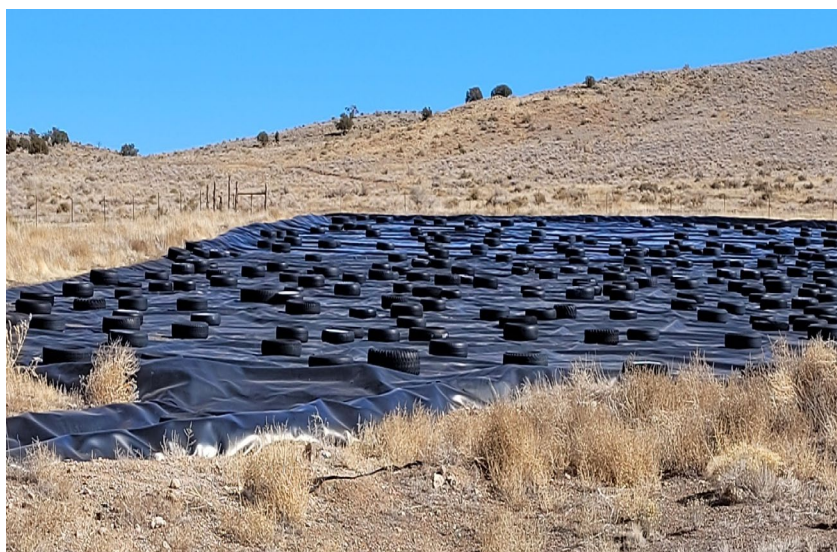
**Figure 1.** *Rubber Water Catchment Apron Anchored With Used Tires*

Due to the unpredictability of rain and the soil's inadequacy to hold water for sufficient lengths of time, using earthen reservoirs to catch and store water can be unreliable (Cooley et al., 1978). A catchment system is a more water-efficient alternative, requiring less land and vegetation disturbance. A rubber water catchment apron is spread over an area of cleared soil with a slope of 5% to 8% and anchored with used tires to avoid wind damage (Cooley et al., 1978; Figure 1). When it rains or snows, water is piped from the apron in high-density polyethylene pipe to a tank or lined pond with a capacity of 80,000–200,000 gallons.

The amount of land for the apron and the required tank size are calculated to fill the storage tank with 75% of the area's average precipitation. For example, in an area receiving 10 inches of average annual precipitation, a 100,000-gallon storage tank

would require a half-acre apron because each inch of precipitation yields approximately 27,000 gallons of water over 1 acre (Bureau of Land Management [BLM], 2017).

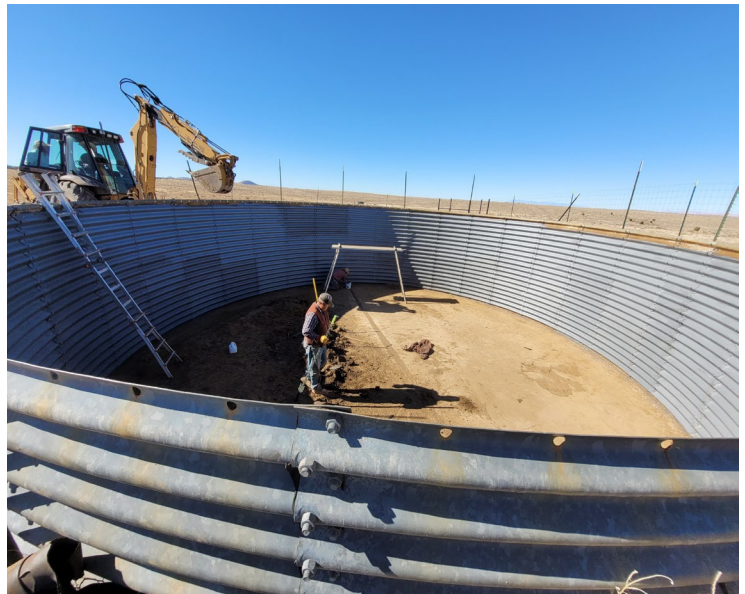
**Figure 2. Steel Catchment Tanks Can Hold up to 200,000 Gallons of Water**

Aboveground or belowground storage tanks are typically steel sided with a concrete bottom (Figure 2). A fence is constructed around the apron, underground tanks, and lined ponds to avoid damage by or entrapment of animals. Storage tanks have wildlife escape ramps and floating bird ladders if they are not covered with a lid. Water from the tank or pond is piped to troughs or guzzlers for availability to wildlife and livestock.

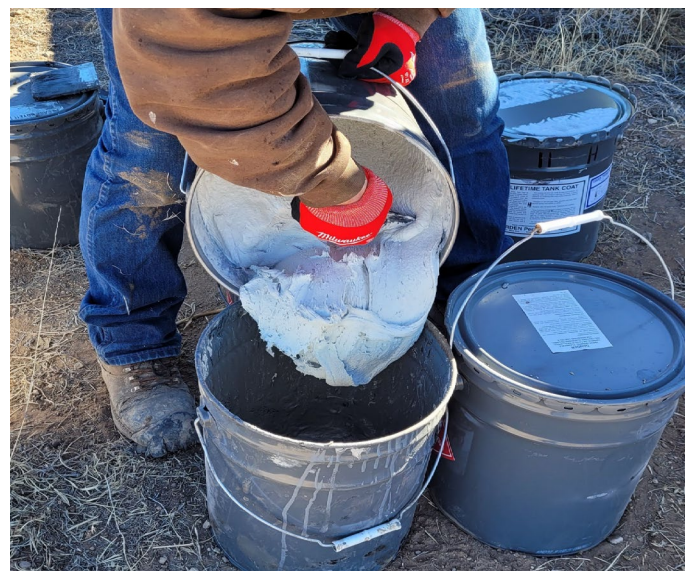
**Figure 3. Mix Epoxy Resin and Hardener in Equal Parts**

- Step 1. Select epoxy that is labeled for tank and trough use and is safe for potable water.
- Step 2. Combine epoxy resin and hardener in equal parts using a cordless drill and mixing attachment (Figure 3).

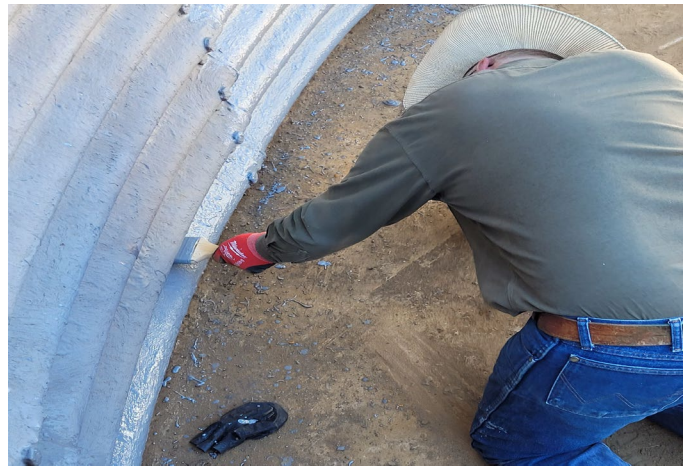
**Figure 4. Completely Seal All Seams, Cracks, and Crevices**

- Step 5. Apply the thinned mixture with a bristled paintbrush, making sure to evenly coat all crevices, joints, bolts, and cracks (Figure 4).
- Step 6. Allow the epoxy to cure overnight.

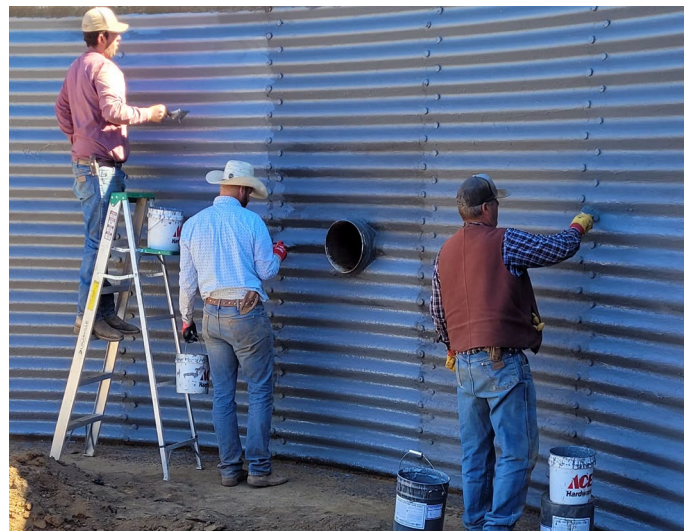
**Figure 5. After Application, Wait 24 Hours and Apply a Second Coat of Epoxy**

- Step 7. Apply a second coat of epoxy, repeating Steps 5 and 6 (Figure 5). A second coat of epoxy must be applied to fill all pores remaining after a single coating (Vodak, 2017).
