Hazard Analysis of a Segment of Highway SR-12 through Bryce Canyon National Park, Southern Utah

HAZARD ANALYSIS OF A SEGMENT OF HIGHWAY SR-12 THROUGH BRYCE
CANYON NATIONAL PARK, SOUTHERN UTAH

Tomsen Reed

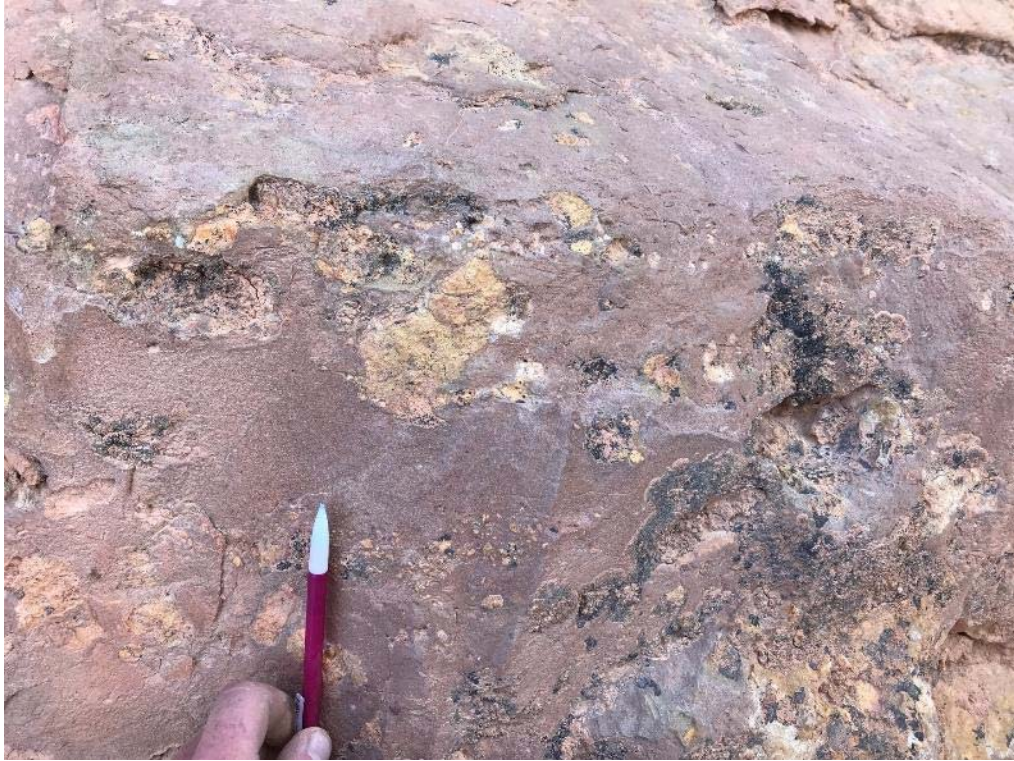
Sample 1B (Figure 28) was taken from the basal limestone, few pebble lenses and angular clasts of dark yellowish brown sandstone (possibly underlying Wahweap Formation). This limestone weathers to a light purple to light olive green on the surface, but fresh faces are generally pinkish orange. It is massive in terms of sedimentary structures, reacts strongly with hydrochloric acid, and has some cavities at fractures. Contact between 1A and 1B is gradational, and difficult to identify in fresh surfaces, but weathered surfaces are more easily distinguished (Figure 25).

Figure 28 - Unit 1B found at Scanline 1. Weathered surface, with visible subangular inclusions of yellowish brown sandstone clasts, along with what appear to be pebble lenses. Pencil for scale (full length 15 cm.)

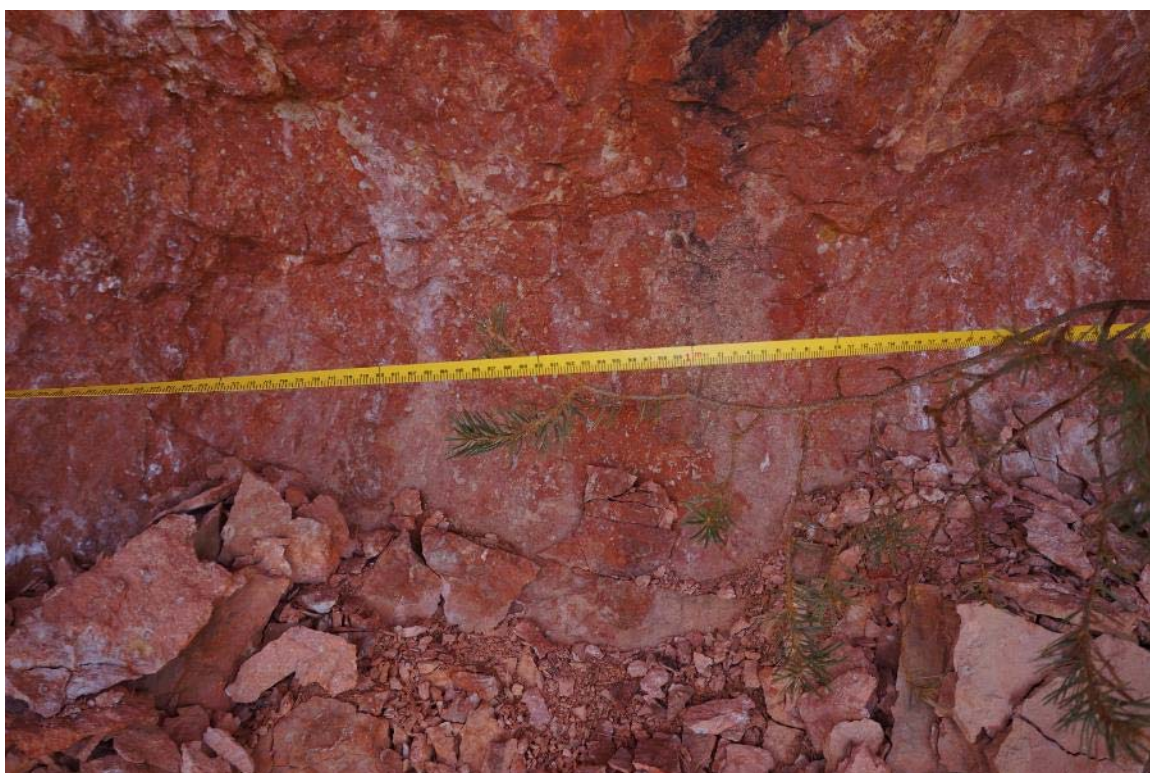
2 centimeters in diameter, filled with calcite crystals, possibly burrows. The color of the limestone ranges from light pink to orange, with black staining around major fractures. It is massive in terms of bedding, and sedimentary structure, and is very fine-grained, possibly micritic. It reacts strongly to hydrochloric acid.

Figure 32 - View of limestone at Scanline 2, metric tape measure for scale (in cm.), rock faces near tape measure are mostly fresh

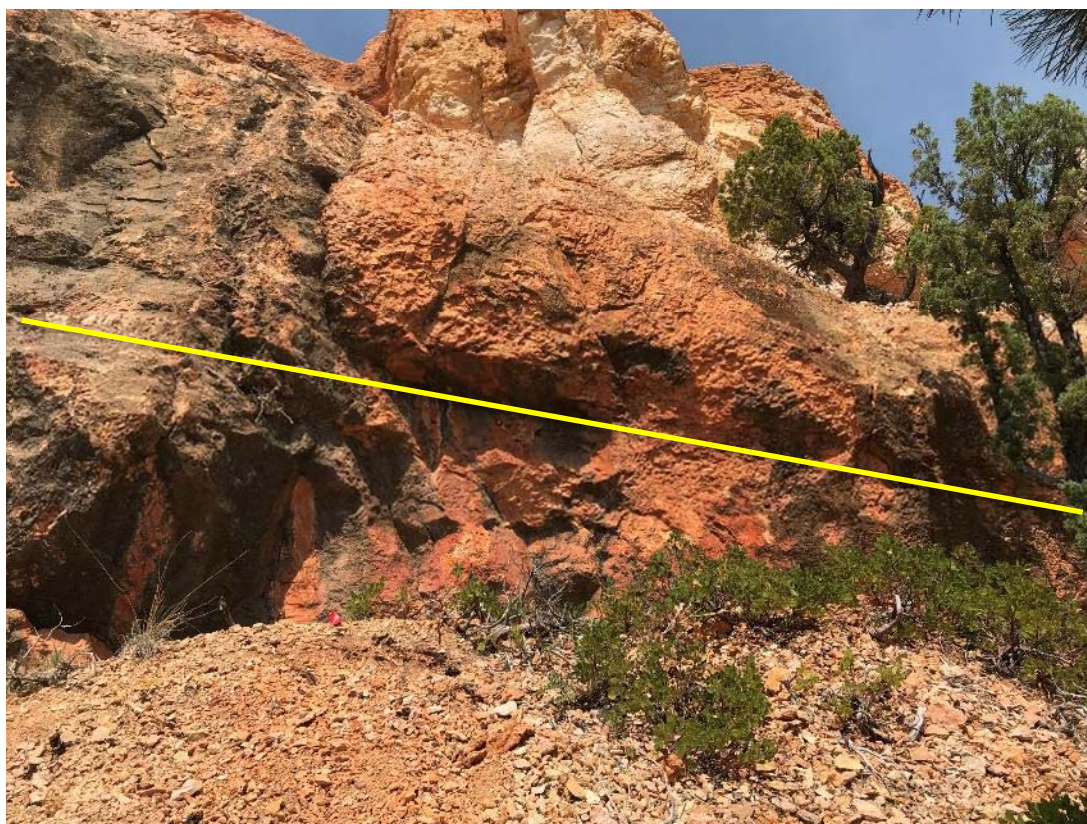
Scanline 3 was performed in an outcrop that was approximately 15 to 20 meters high in total height. The outcrop contained 1 unit that could be observed from the scanline location (Figure 34).

Figure 34 – Partial outcrop view of Scanline 3 location. Scanline location marked in yellow. View to the northwest from just below the scanline location.

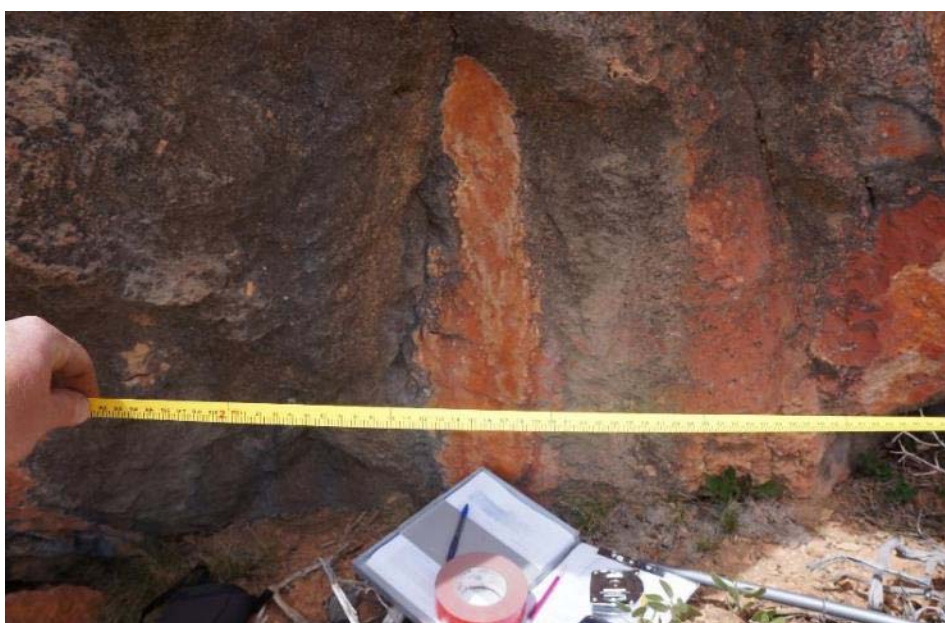
Scanline 3 was performed in a dolomite (Figure 35), with some cavities filled with calcite crystals. The color of the dolomite ranges from light pink to orange, with black staining on a large portion of the outcrop. It is massive in terms of bedding and sedimentary structures, and is very fine-grained, possibly micritic.

Figure 35 - Dolomite found at Scanline 3, with abundant manganese oxide staining visible on the surface. Tape measure showing scale (in cm.).

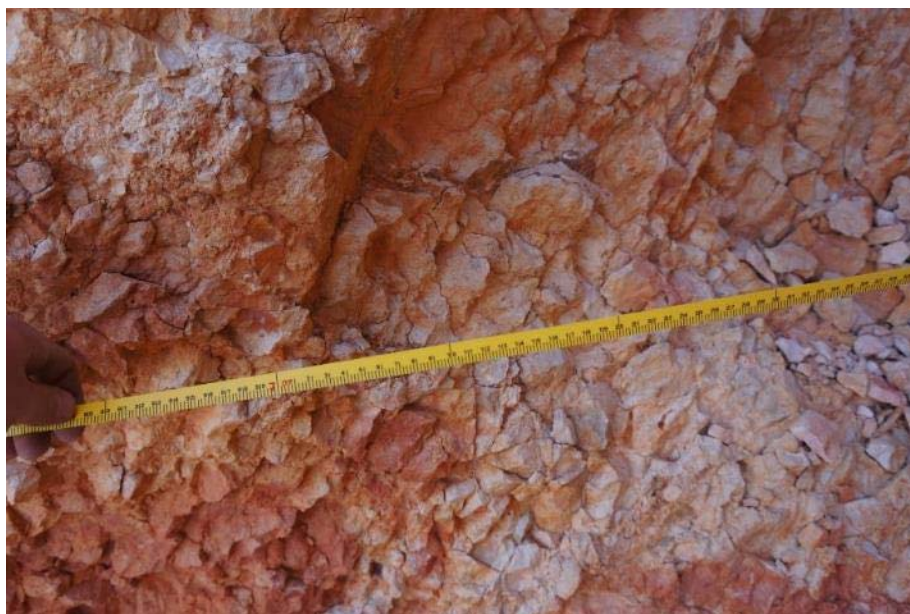
From the two units that were crossed by Scanline 4, samples were collected from each unit. Units 4A and 4B are described below, and samples from these units were labeled samples 4A and 4B. Sample 4A (Figure 38) was taken from a limestone that contains some subrounded inclusions from 1 to 6 mm, possible burrows. It is light pink to orange to light tan, and weathers to light to dark gray and occasionally yellowish brown. Some joints and cavities in this unit are filled with calcite crystals. It displays numerous small-aperture and short-length fractures at this location, which are interpreted to be dissolution cleavage.

Figure 38 - Unit 4A, limestone found at Scanline 4, with dissolution cleavage, rock faces are mostly fresh

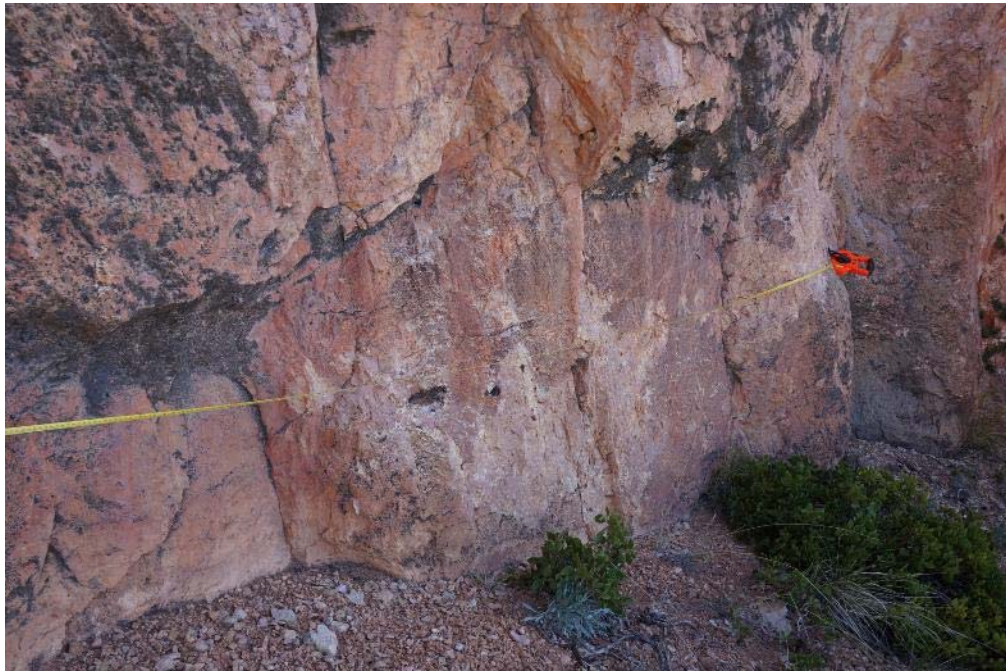
Scanline 5 was performed in an outcrop that was approximately 15 to 20 meters high. The outcrop contained 1 unit that could be observed from the scanline location (Figure 41). The unit was possibly overlain by different units, but these could not be described due to access.

Figure 41 - Wider view of Scanline 5

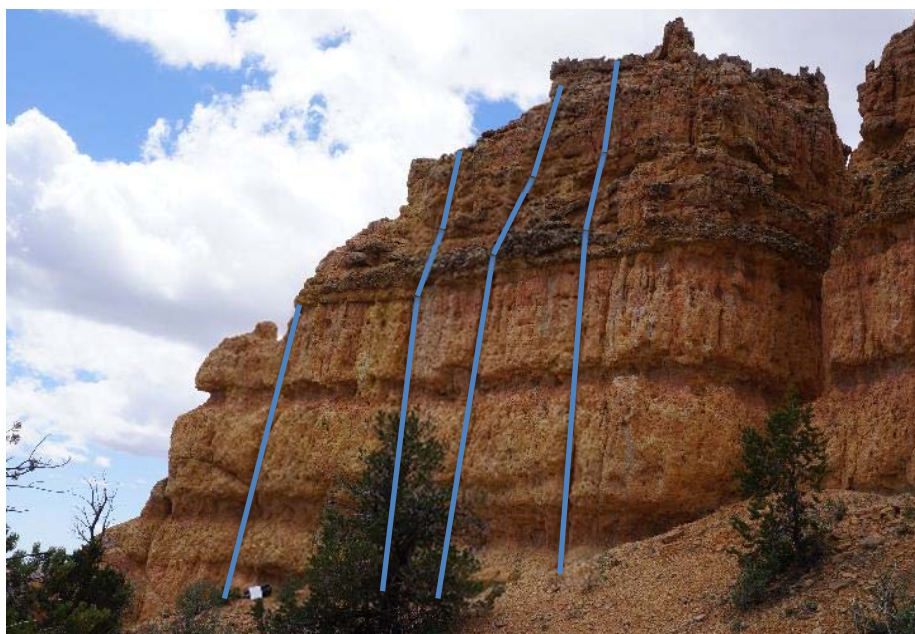
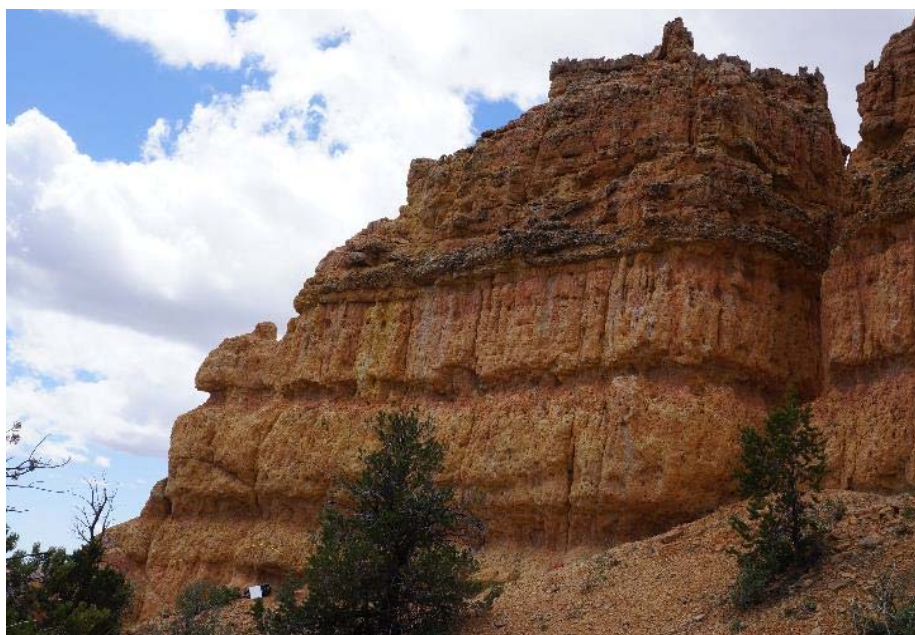
Figure 48 - Scanline Control outcrop with major, near-vertical fractures marked in blue (upper photo) and unmarked but visible in lower photo

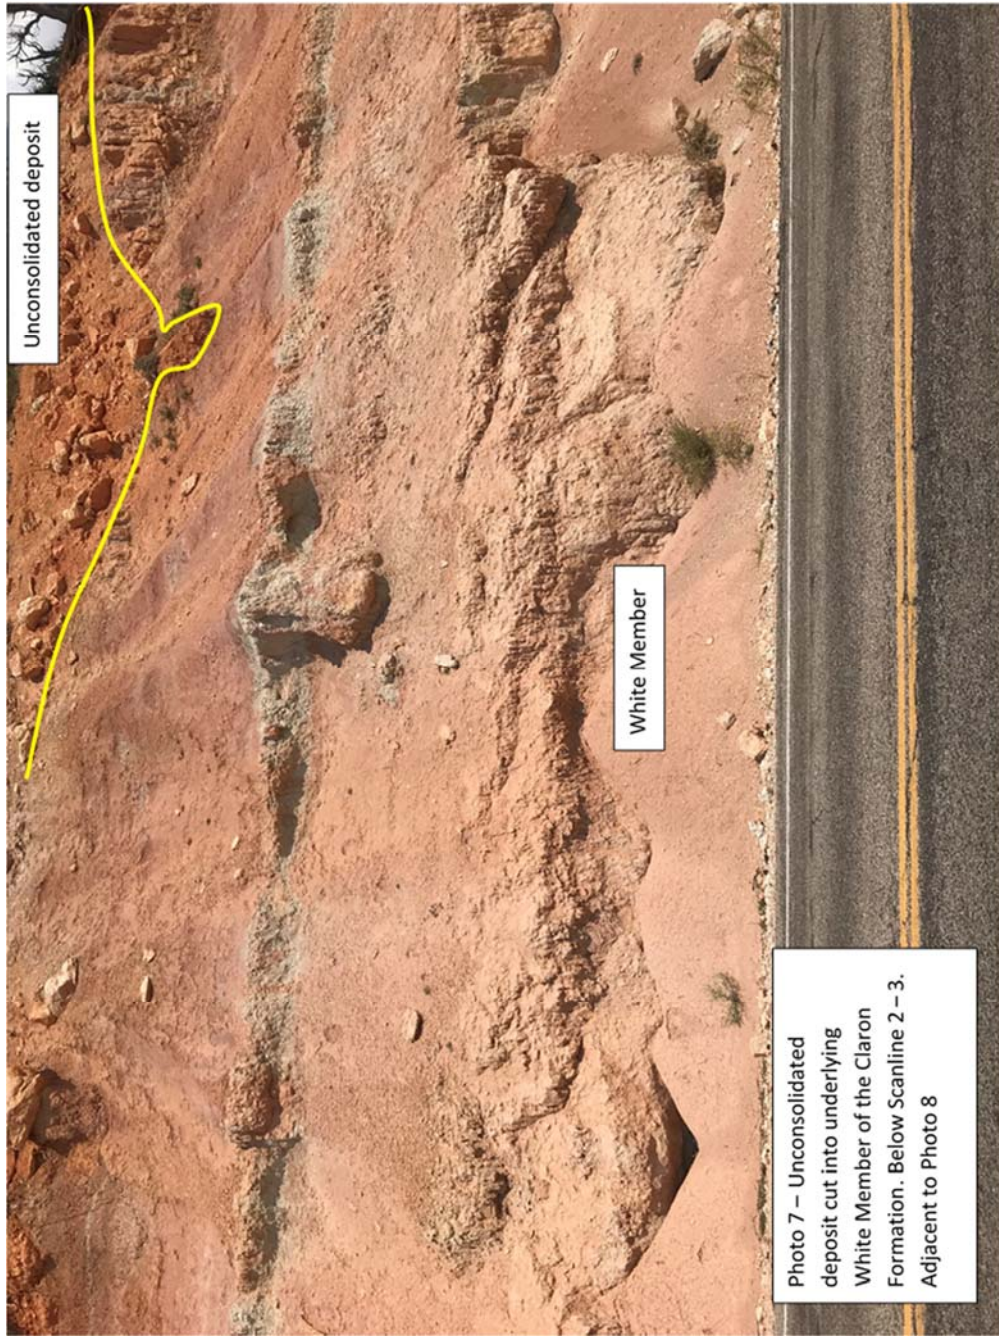
Figure A-9 – Photograph of unconsolidated deposit in roadway below Scanlines 2 and 3

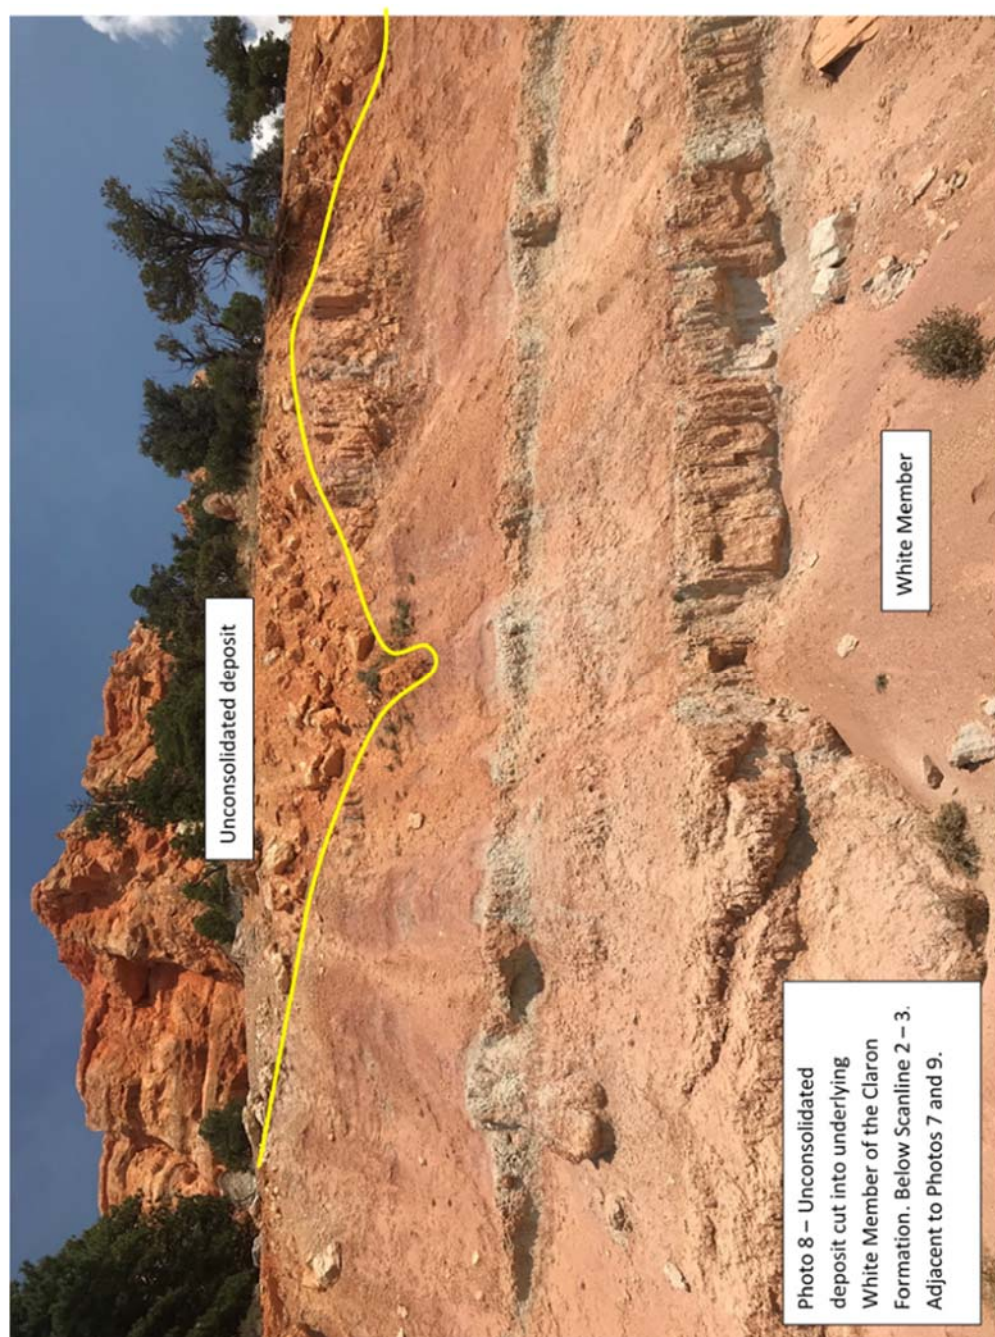
Figure A-10 – Photograph of unconsolidated deposit in roadway below Scanlines 2 and 3

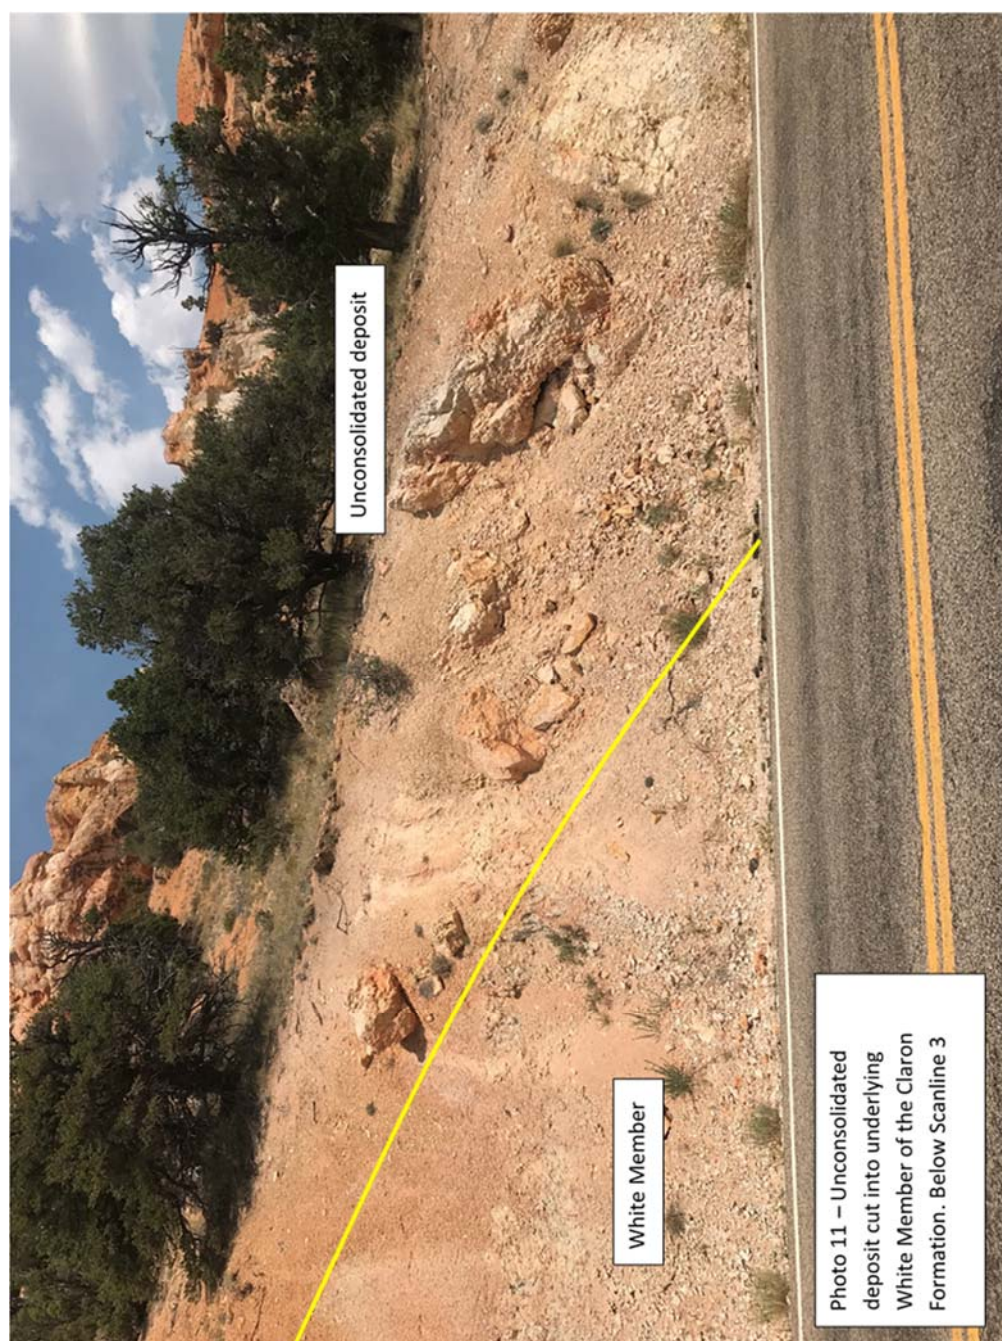
Figure A-13 – Photograph of unconsolidated deposit in roadway below Scanline 3

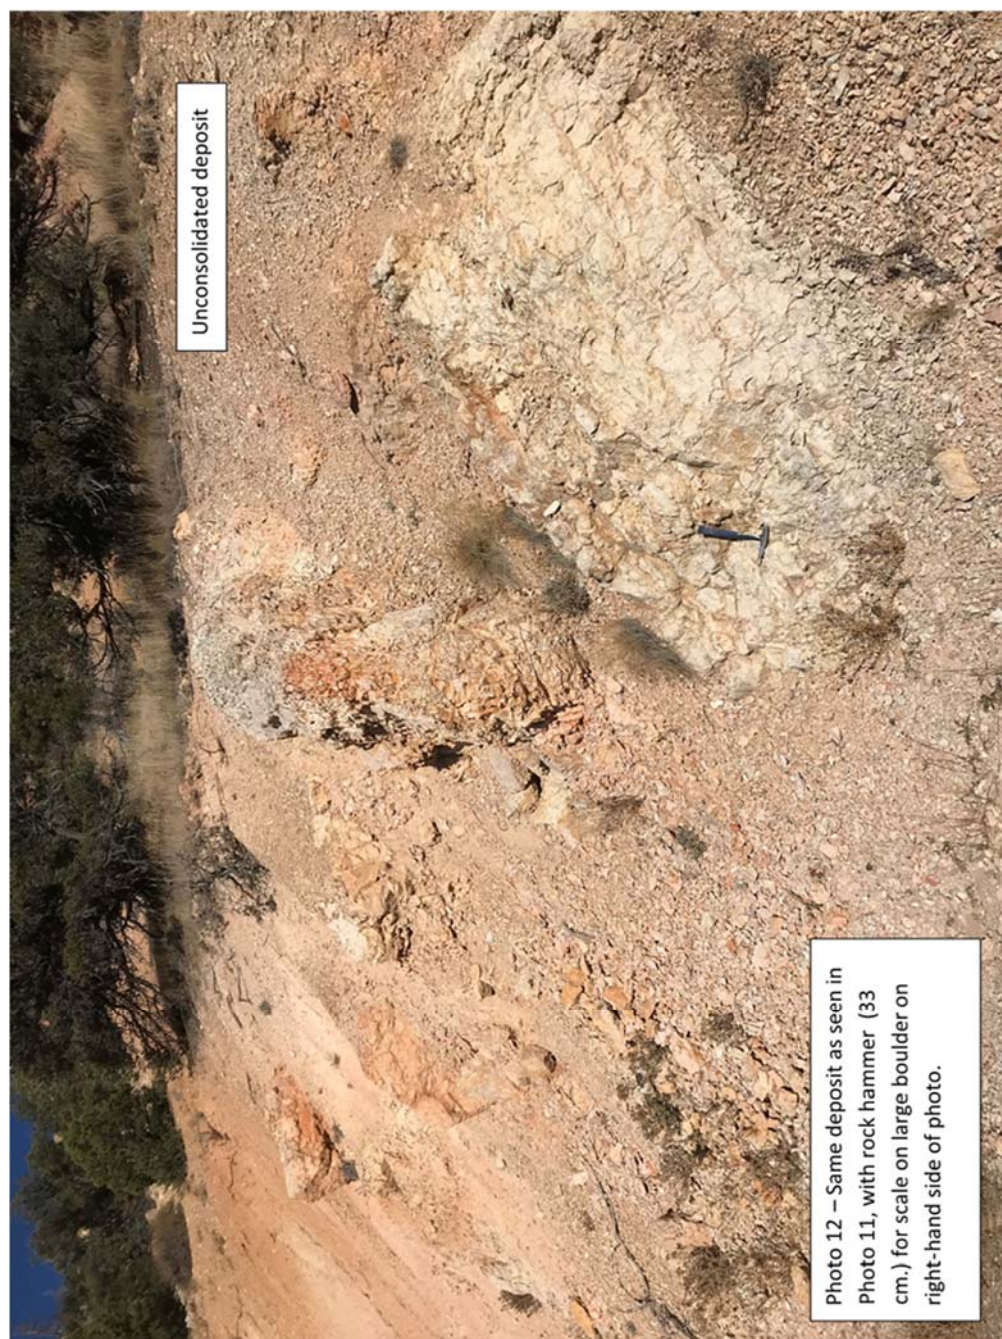
Figure A-14 – Photograph of unconsolidated deposit in roadway below Scanline 3

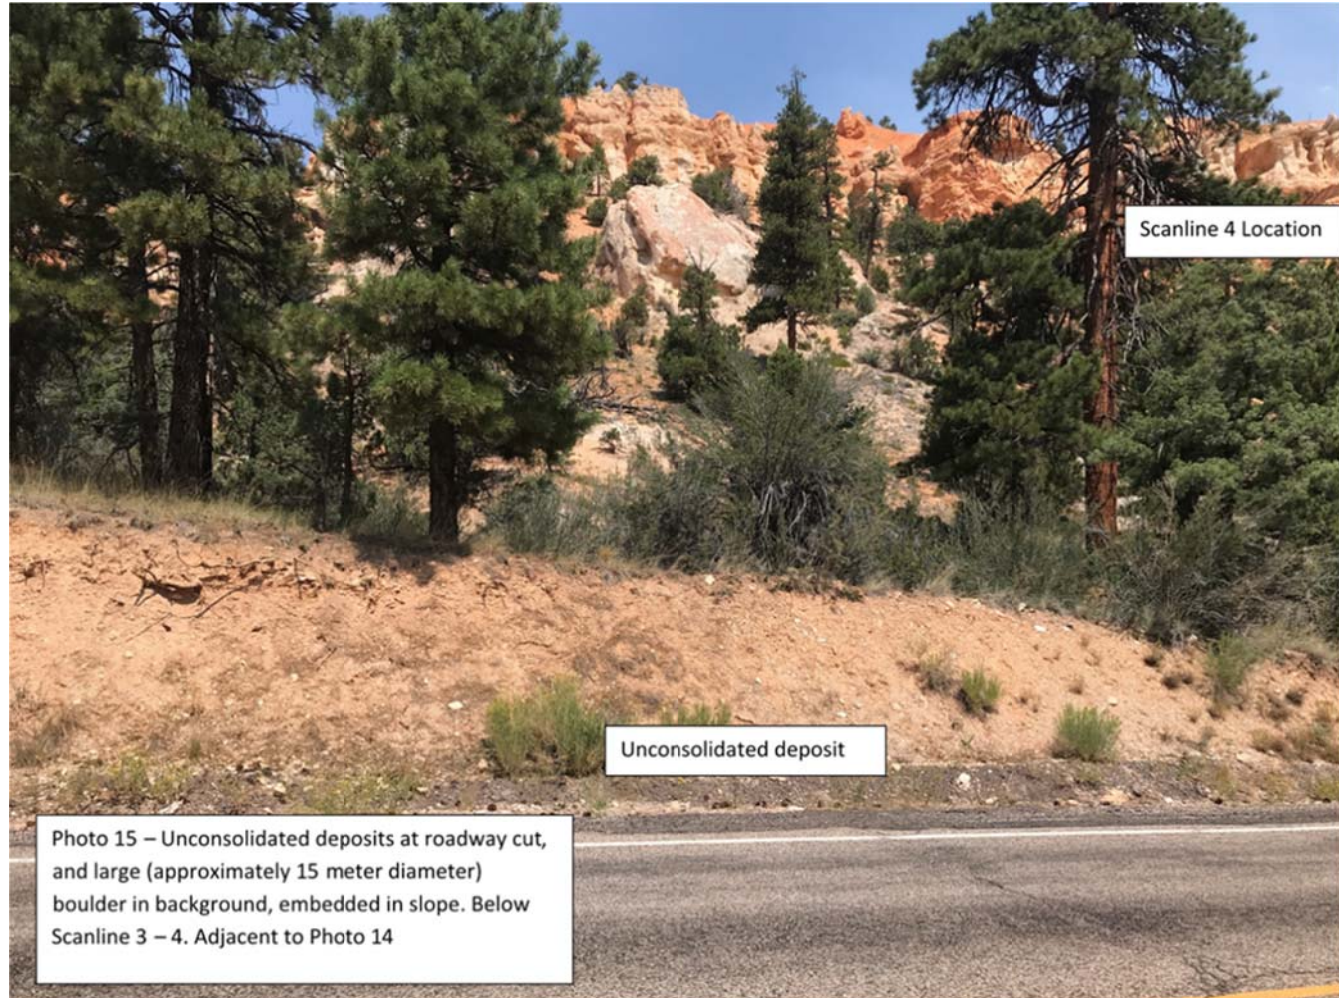
Figure A-17 – Photograph of unconsolidated deposit in roadway below Scanlines 3 and 4

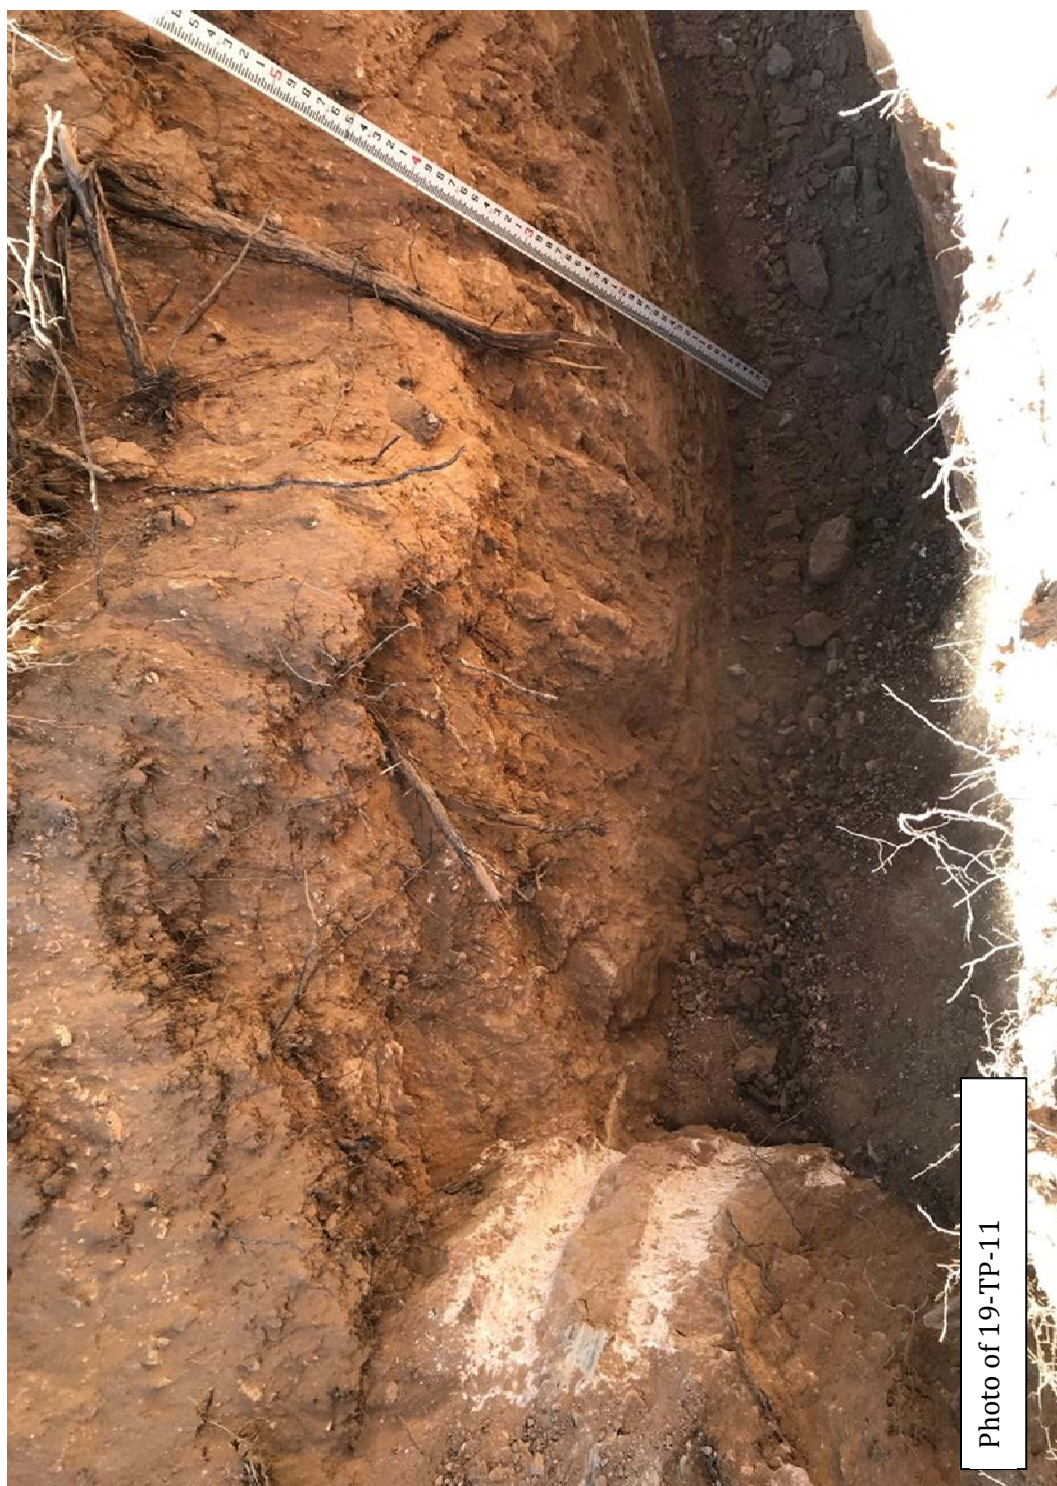
Photo of 19-TP-11

IIIa – LIMESTONE, very fine grained, orange to light tan, thickly bedded, fresh to slightly weathered, moderately hard. Unable to safely gather discontinuity data inside the test pit, but an analogous outcrop was exposed in the road cut below the test pit, which indicated that the limestone was moderately to intensely fractured, with moderately spaced, discontinuous to slightly continuous horizontal fractures and closely spaced, discontinuous vertical fractures, generally slightly open to open, with very thin to thin fracture filling, not healed, moderately rough undulating, and the fractures were dry and either showed no evidence of previous water flow or showed some iron oxide staining. [CLARON FORMATION, WHITE MEMBER]

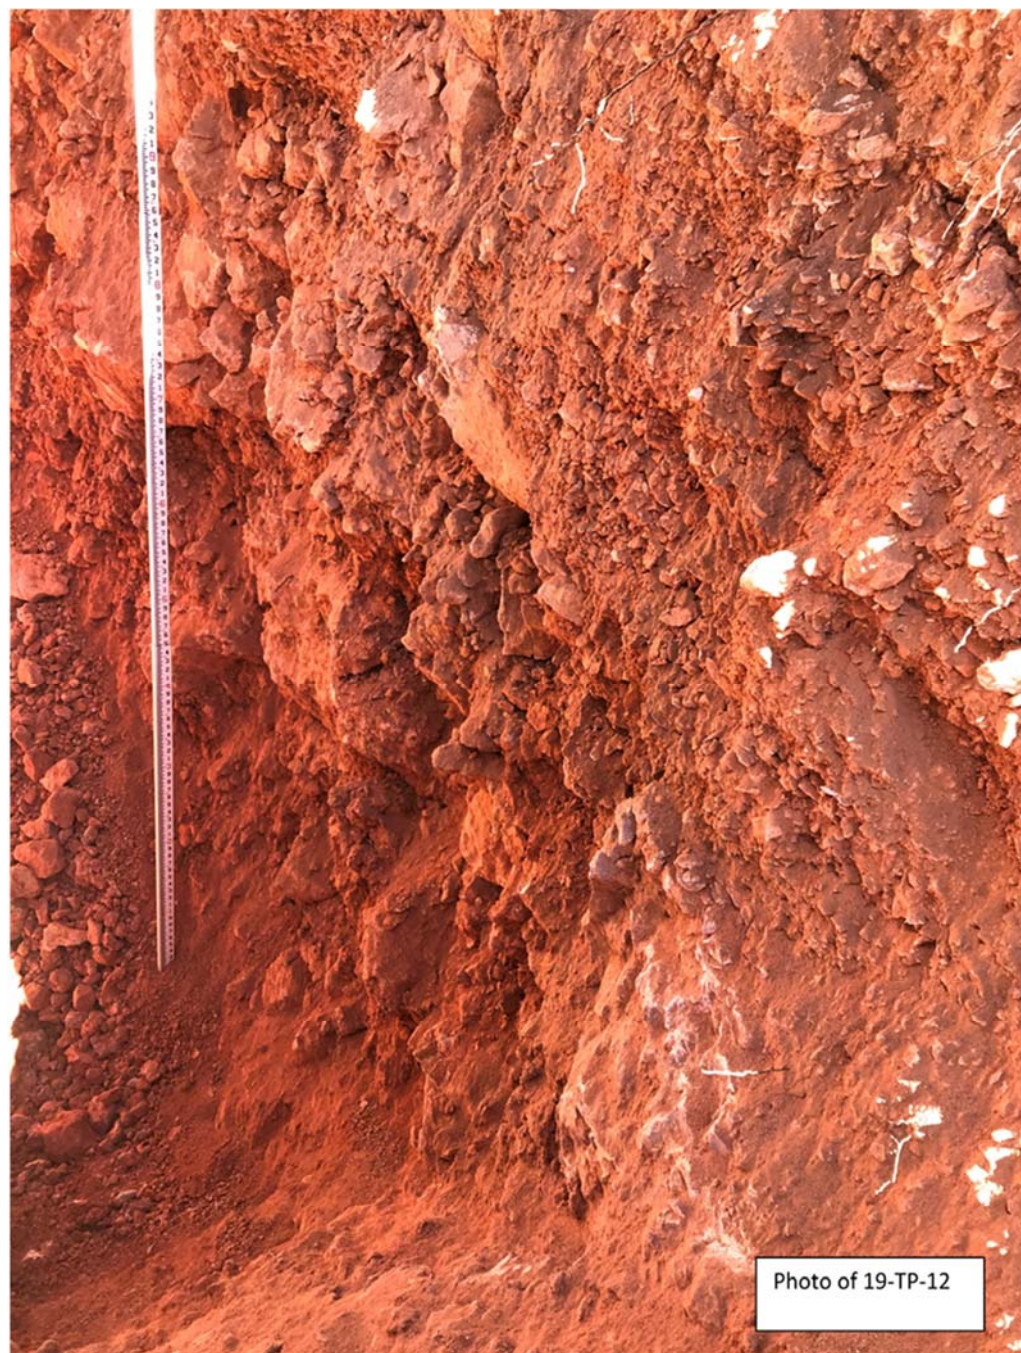
Figure A-27 - Photograph of 19-TP-12 from Gerhart Cole, (2019)

IVc – COBBLES AND BOULDERS, with gravel and sand, some silt. Orange to red, angular to subangular, fine to coarse limestone gravels, cobbles, and boulders, fine to coarse sand, [COLLUVIUM WITH LENSES OF TALUS]

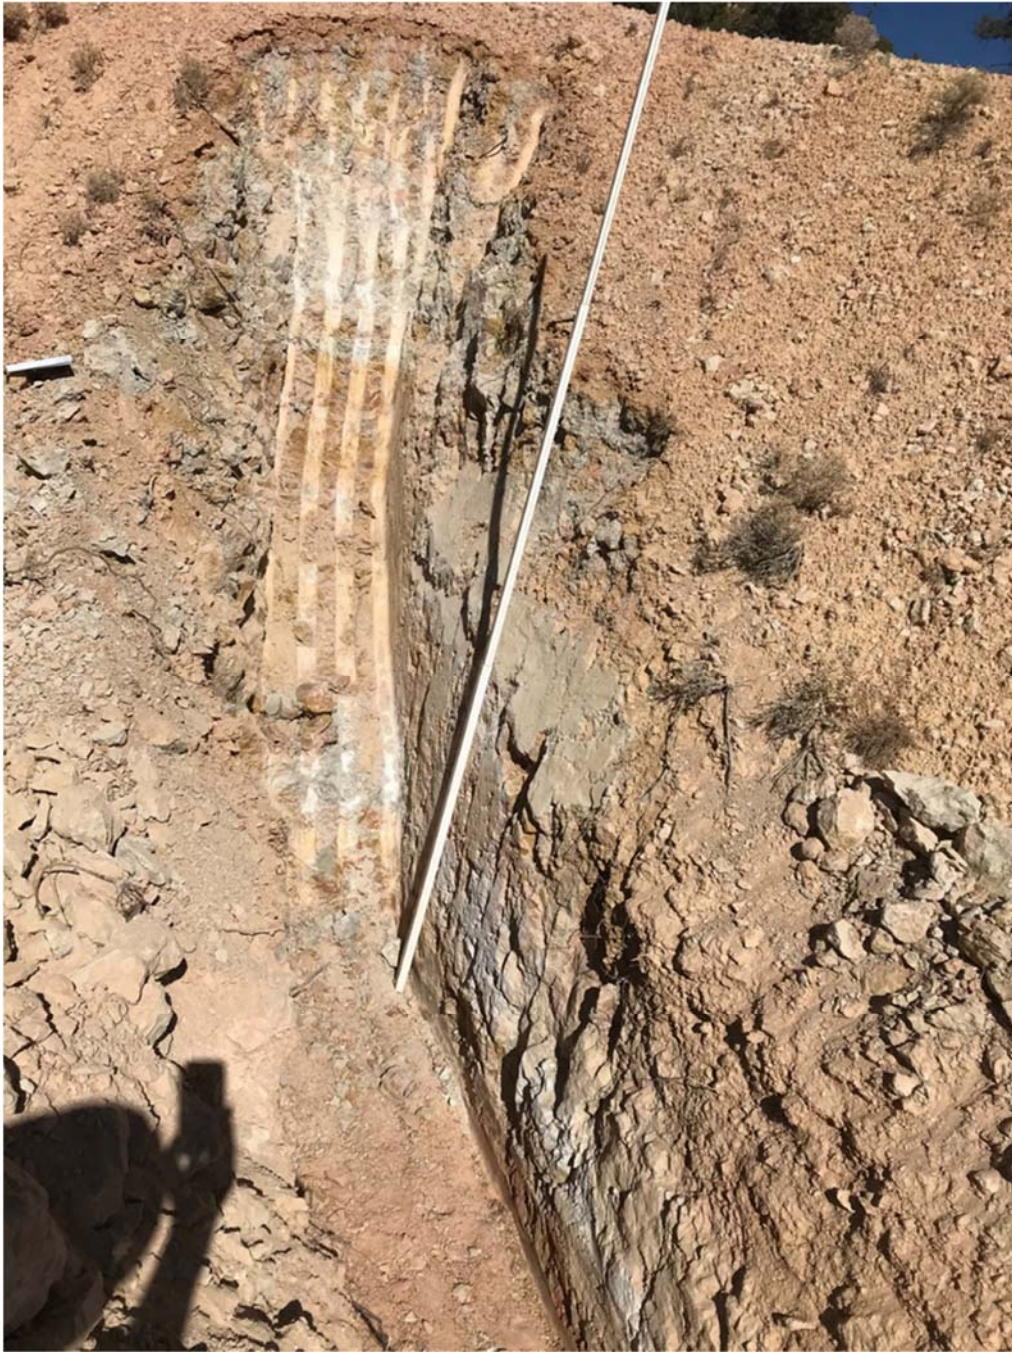
Figure A-29 - Photograph of 19-TP-13 from Gerhart Cole, (2019)

IIIA – LIMESTONE, very fine grained, light tan to pale olive brown with occasional pink to red staining, thickly to very thickly bedded, fresh to slightly weathered, moderately hard, moderately to intensely fractured, generally closely spaced, discontinuous fractures, slightly open to open fractures with very thin to thin sand and clay fracture filling, not healed, moderately rough undulating, with no evidence of previous water flow, although flow appears possible. [CLARON FORMATION, WHITE MEMBER]

IIIC – MUDSTONE, olive brown to tan, moist, soft, very fine grained, very thinly bedded to laminated, soft, slightly weathered, difficult to accurately assess fractures due to disturbance in the layer from trackhoe excavation, but appears to be intensely fractured with very closely spaced, discontinuous, tight to slightly open fractures with very thin fracture filling, not healed, smooth planar fractures, with no evidence of previous water flow but flow appears to be possible. [CLARON FORMATION, WHITE MEMBER]

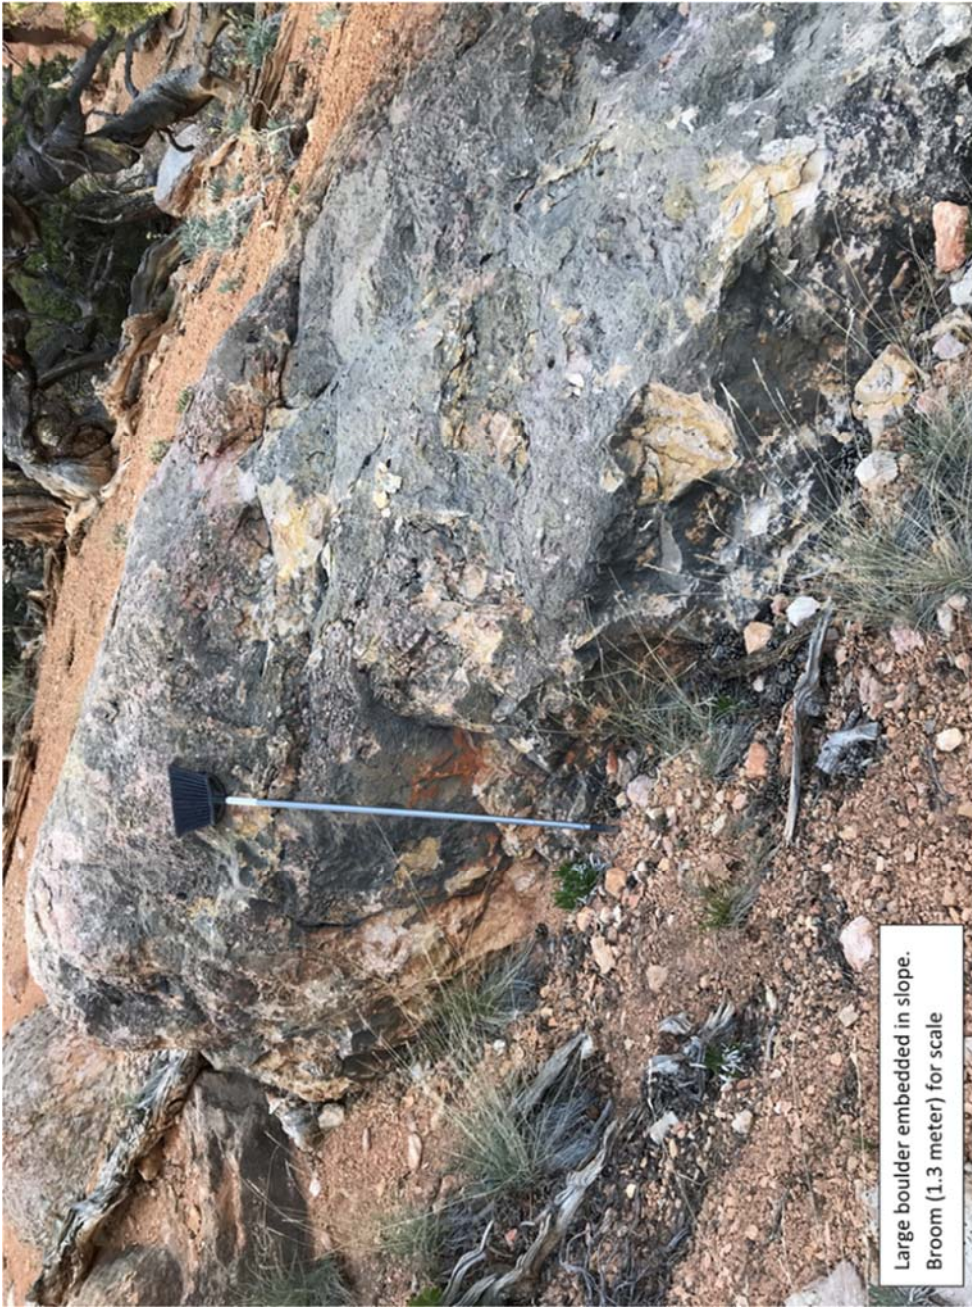
Figure C-4 – Large boulders partially embedded in the slope near Scanline 4

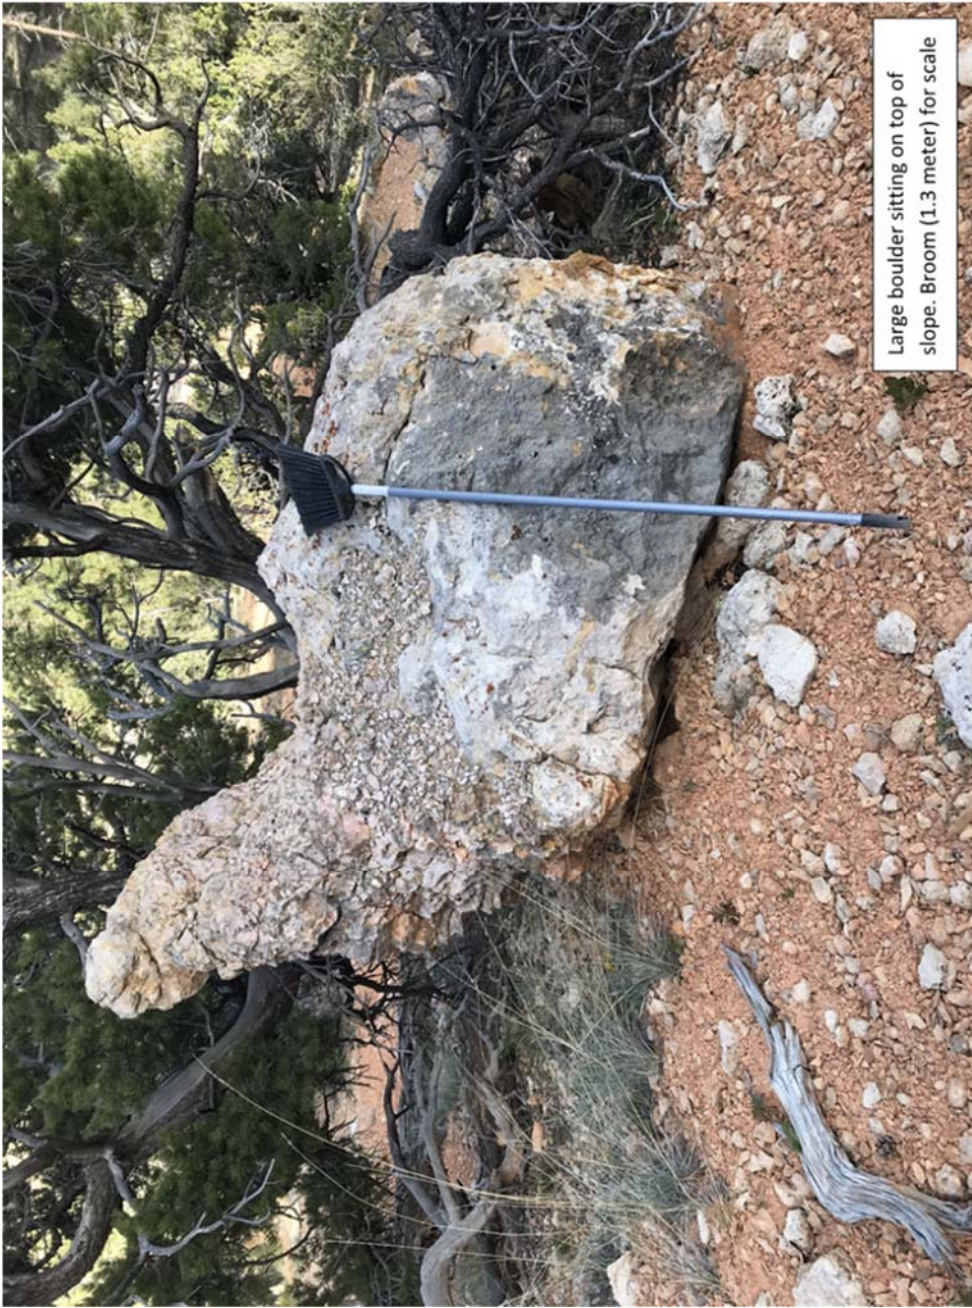
Figure C-5 – Very large boulder partially embedded in slope

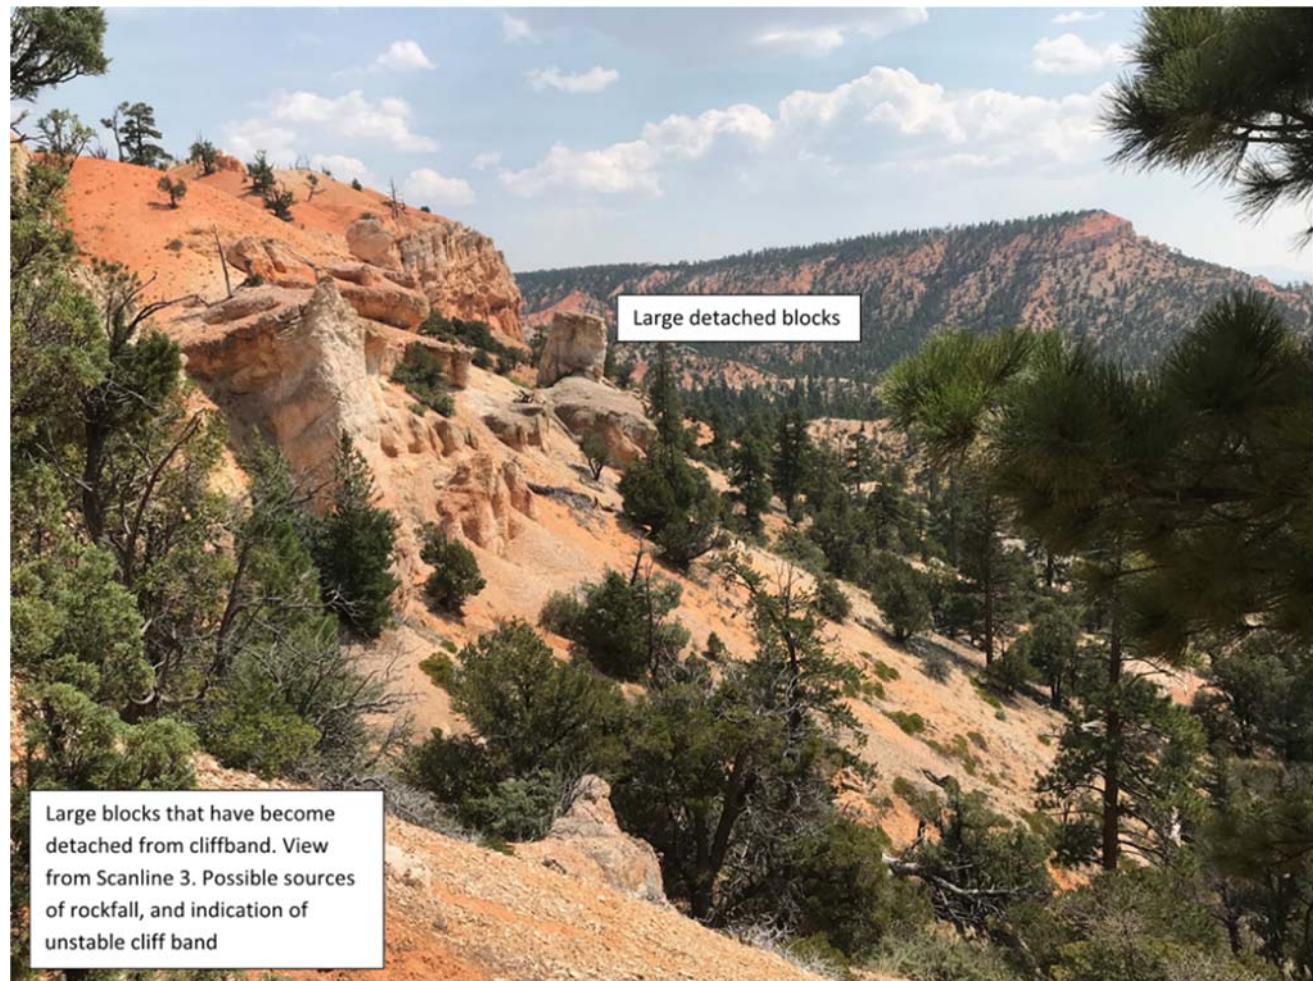
Figure C-10 – Photograph of boulders sitting just above the roadway cut, between Scanlines 4 and 5
